Manhole Inspection Summary

Manhole # S57E__023MH

Insp Date: **6/30/08 9:10 AM**

Location Address: **200 s haven st**

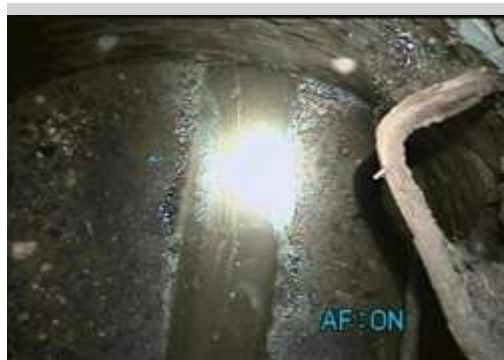
Top View

inside top view

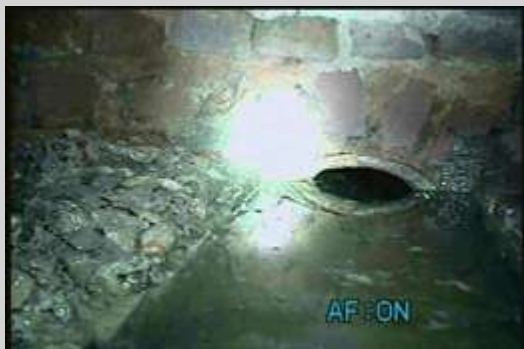
6 O'Clock Inflow

8 in. Circular Gravity Sewer
Pipe In @ 6 O'Clock

Pipe Height: 0 (in.) Direct

Pipe Material: **Clay** ☐ Pipe Lined

Infiltration: **None** Pipe Seal Cond: **Unknown**
